**ELISEU VISCONTI'S  
MONUMENTAL  
MAROUFLAGE  
WALL PAINTINGS:  
CONSERVATION, CONTEXT,  
AND TECHNICAL  
EXAMINATION**

**Keywords:** mural paintings, marouflage, pigments, brushwork, colors, Modular Cleaning Program

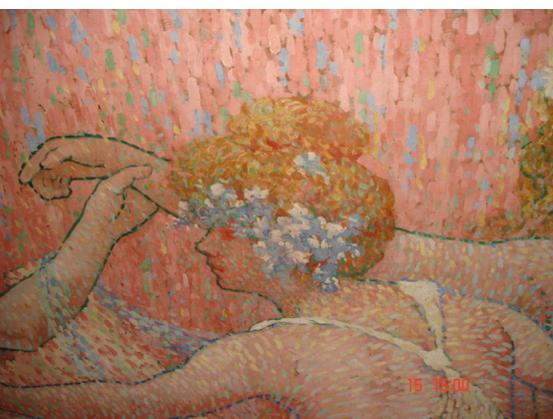
**Figure 3**  
*A Dança das Horas*, detail

The subject matter – *A Dança das Horas* (The Dance of Hours) – comes across very convincingly as elegant female figures, painted in light colors, dancing hand in hand across the picture plane. The segments representing daylight hours are painted in luminous warm colours, with dusk and night in bluish shadows. All the figures of the composition are monochromatically under-modeled with a brownish umber-like tint that remains visible in the shades and middle tones as lighter flesh pinks progress towards discrete highlights. The contours of the figures are strongly delineated with dark viridian green and, in some figures, with an intensely chromatic cobalt blue line.<sup>3</sup> Over the flesh tones of the modeled figures, Visconti painted a myriad of small light dots of color, usually light blue, which contrasted with the warm skin colored under-layer. These small brushstrokes are aligned sinuously to reinforce the sensation of moving air, flow, and rhythm. This can be traced back to the influence of French paintings, as in his notebooks the artist writes about Henri Martin's murals commissioned for the capitol in Toulouse: "The air circulates all around. For values three at most. The mixture of colors is obtained by juxtaposition and not blended to each other. This is the fresh and luminous result that can be seen in his pictures" (Cavalcanti 1997). On the other hand, the representation of hair, details of drapery, flowers, and ribbons are done with a fluid and confident *alla prima* handling in a more direct depiction of the iconography (Figure 3).

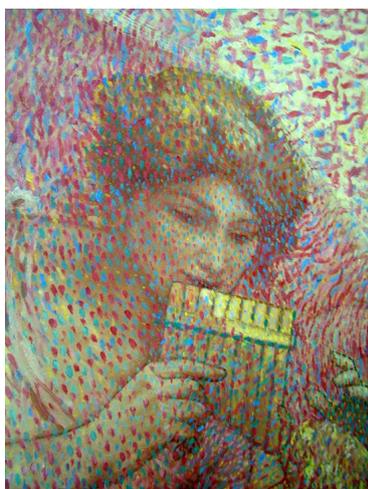
**Figure 4**  
*A Música*, detail

The figures are monochromatically modeled much in the same manner as his circular composition in the *plafond*, but the chromatic outline reinforcing their silhouette is absent from most of the *foyer* figures.<sup>4</sup> The use of contour lines was reserved for some isolated figures set against a non-contrasting background. The tangible edge of each modeled figure is painted darker and in some cases shows a distinct brownish contour, unlike the *plafond* painting, *A Música* blends background and foreground through effective diffuse brushwork applied over the figures in smaller and more diversified dots and strokes. These are combined with a looser handling of the background in contrast to the more mechanical side-by-side brushwork used on the *plafond*. The background treatment often overlaps onto the figures and in some areas it is hard to distinguish the different planes (Figure 4).

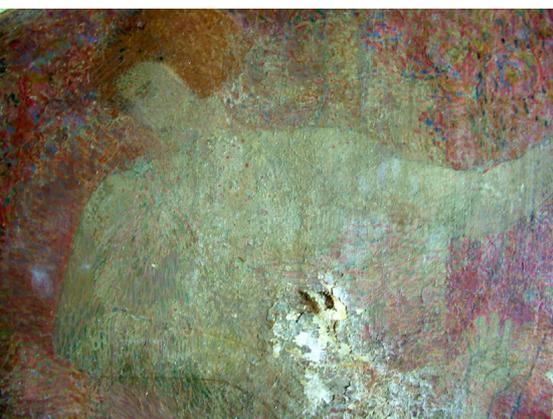
**Figure 5**  
*O Drama* – before conservation, detail

On the other hand, two of the three large paintings decorating the *foyer*; *O Drama* and *A Arte Lirica*, were in very bad condition. The history of their conservation dates back to the 1930s, when intense tropical rains caused the copper covered roof to leak, soaking the walls and causing the lime/sand plaster to lose cohesion, with consequent detachment of the canvas from the wall as well as extensive delamination and paint loss in large areas. This pattern repeated itself throughout the years and no decade passed without a major disaster. It goes without saying that most of these events were followed by attempts at conservation, some of which were ill conceived, with over-cleaning, thick yellowed varnishes, and darkened repaints disfiguring the appearance of what was intended to be a light and chromatic composition (Figure 5).

These two water-damaged paintings were heavily faced and detached mechanically from the wall.<sup>6</sup> A variation of the traditional *strappo* technique was used, with care being taken not to use contacting adhesives, as the purpose was to remove the precariously adhered canvas from the wall with minimum risk to the paint layer. After consolidation and cleaning of the reverse, *O Drama* was mounted on honeycomb panels, under vacuum. The decision to adhere these paintings on such alien supports was taken with some degree of concern as the technical nature

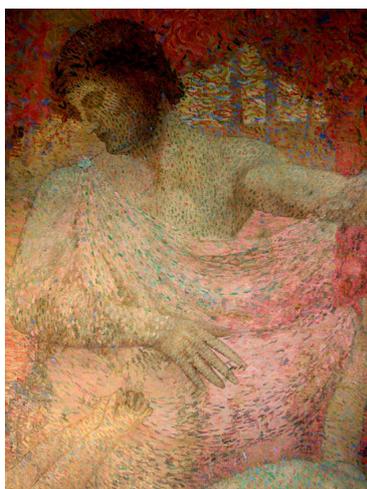
**Figure 7**

*O Drama*, after conservation

of the original *marouflage* would be permanently altered. However, this was weighed against the very real risk of future roof leaks and was mitigated by the acknowledgement that the flat, rigid appearance of a *marouflaged* painting could be duplicated by mounting on a honeycomb panel.<sup>7</sup> Beva 371, a heat-activated polyethylene vinyl acetate-based adhesive was chosen due to its strength and history of over four decades of use in conservation. Water resistance was paramount in this specific project and in the authors' experience, this adhesive performs quite well in high-humidity environments.

To attach the canvas to the panel, a traversing heat source was used to activate the adhesive. This equipment was purpose-built from a 5m × 0.60 metal box containing a closely set arrangement of infra-red lamps. The lamps faced downwards, supported by wheeled legs, allowing the heat source to move across the painting, held under vacuum pressure. Temperatures on the surface of the paint layer hovered around 70°C and sensors embedded in the adhesive reached 65°C. After cleaning, filling, and rather extensive reconstructive inpainting,<sup>8</sup> both paintings appeared uneven and their colors were distinctly under-saturated due to previous harsh treatments and water damage. Although there is no evidence in Visconti's writings that he intended the paintings to be varnished and many of his other surviving paintings were not (Figure 7), a thin varnish layer was deemed necessary to restore color saturation and the characteristic oily sheen that could be gauged (as was his intent?) by observing the pristine state of the paint surface of the *plafond* (Figure 8). A 5% concentration of MS2A resin was the resin of choice due to its outstanding optical properties. To render the surface semi-mat<sup>9</sup> the flattening agent of Winsor and Newton Artists Mat Varnish was left to decant out of solution repeatedly and the clear and progressively more diluted ketone resin was discarded each time. When added to MS2A – different proportions were tested to ascertain the right level of gloss – the result was that of a saturated, yet unvarnished paint surface.

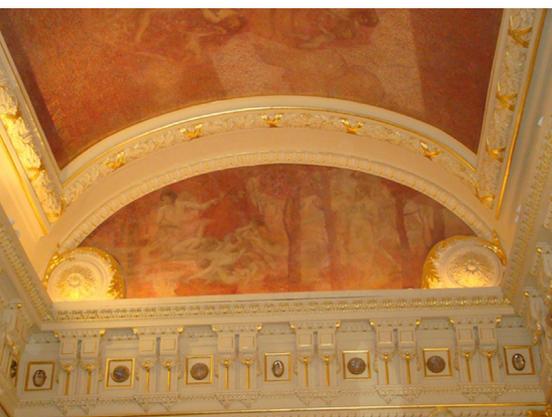
**Figure 8**

*O Drama*, back in situ

Re-installing the panels in their gesso-framed niches was a simple procedure and their appearance as *marouflaged* wall paintings remains very convincing.
